Re: Compliance Stormwater Evaluation Inspection
Cardinal Aluminum Fishing, LLC
Permit No. KYR003672

U.S. Environmental Protection Agency, Region 4
61 Forsyth Street SW, Atlanta, GA 30303
Water Compliance Inspection Report

NPDES ID: KYR003672	Effective Date: 06/01/13	Expiration Date: 05/31/18
Facility Name: Cardinal Aluminum Finishing, LLC	SIC Code: 3312	
Address: 4005 Oaklawn Drive, Louisville, KY 40219

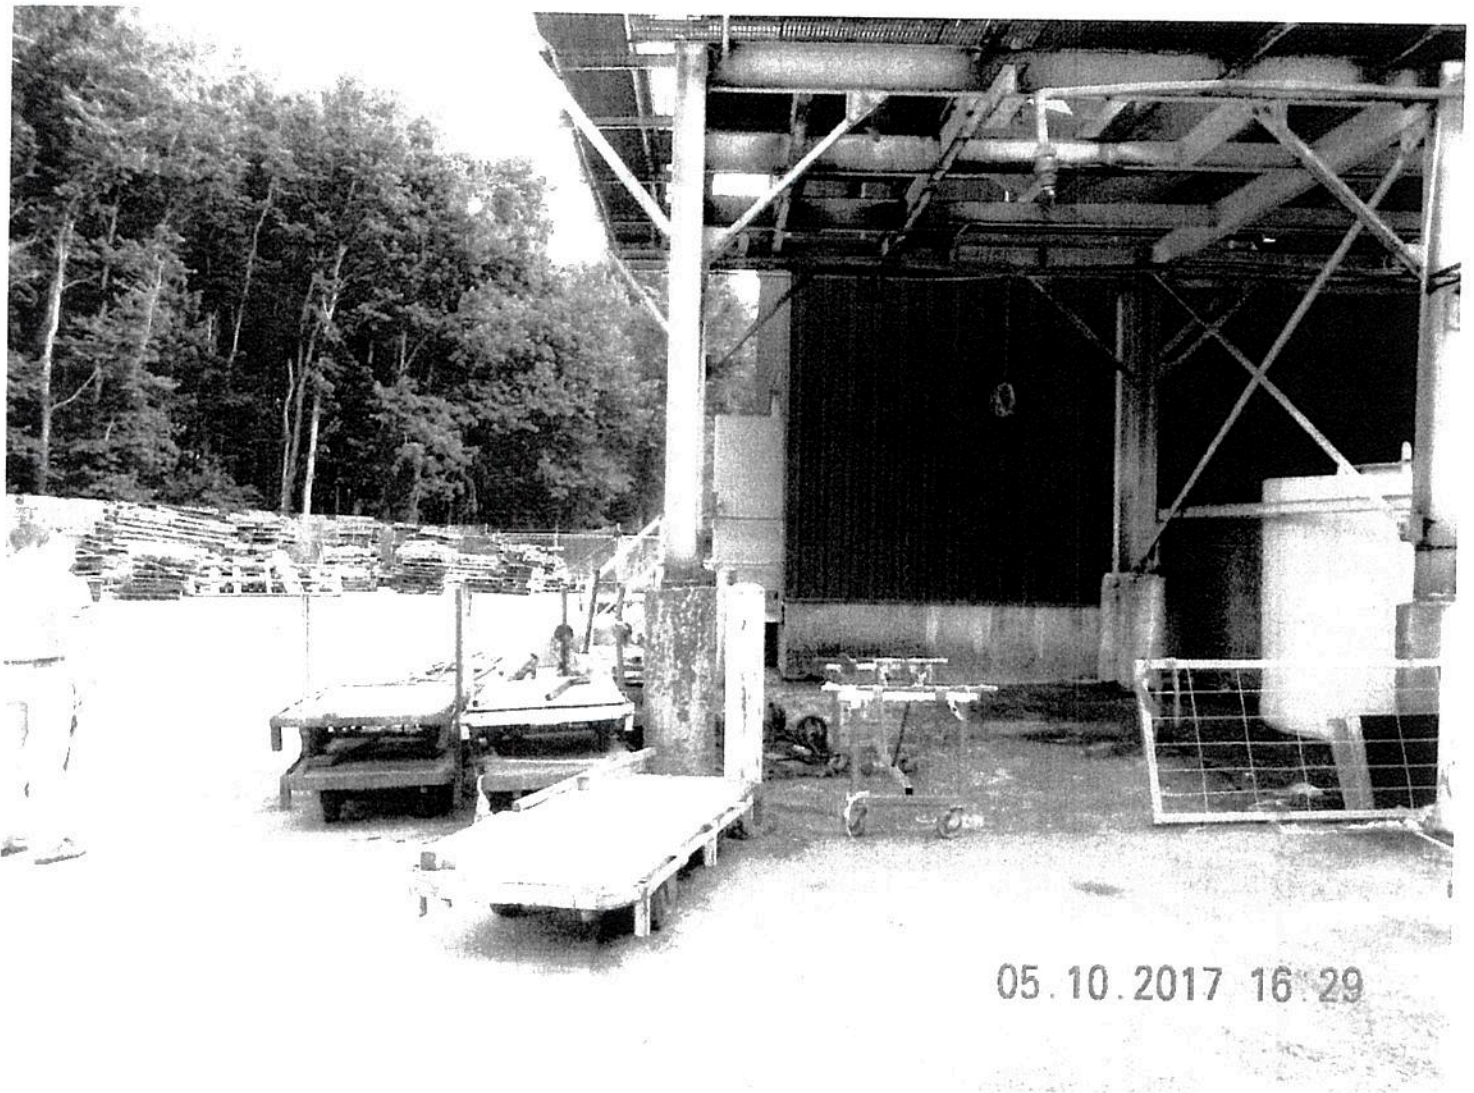
6. *No annual site assessments available for the inspectors to review.*
7. *A trickle of water was observed flowing in the storm drain # 1, Outfall 001, and Outfall 002. The source of these dry weather discharge in stormwater system was not determined.*

Photo No. DSCN1173: A trickle of water was observed flowing in the storm drain # 1.

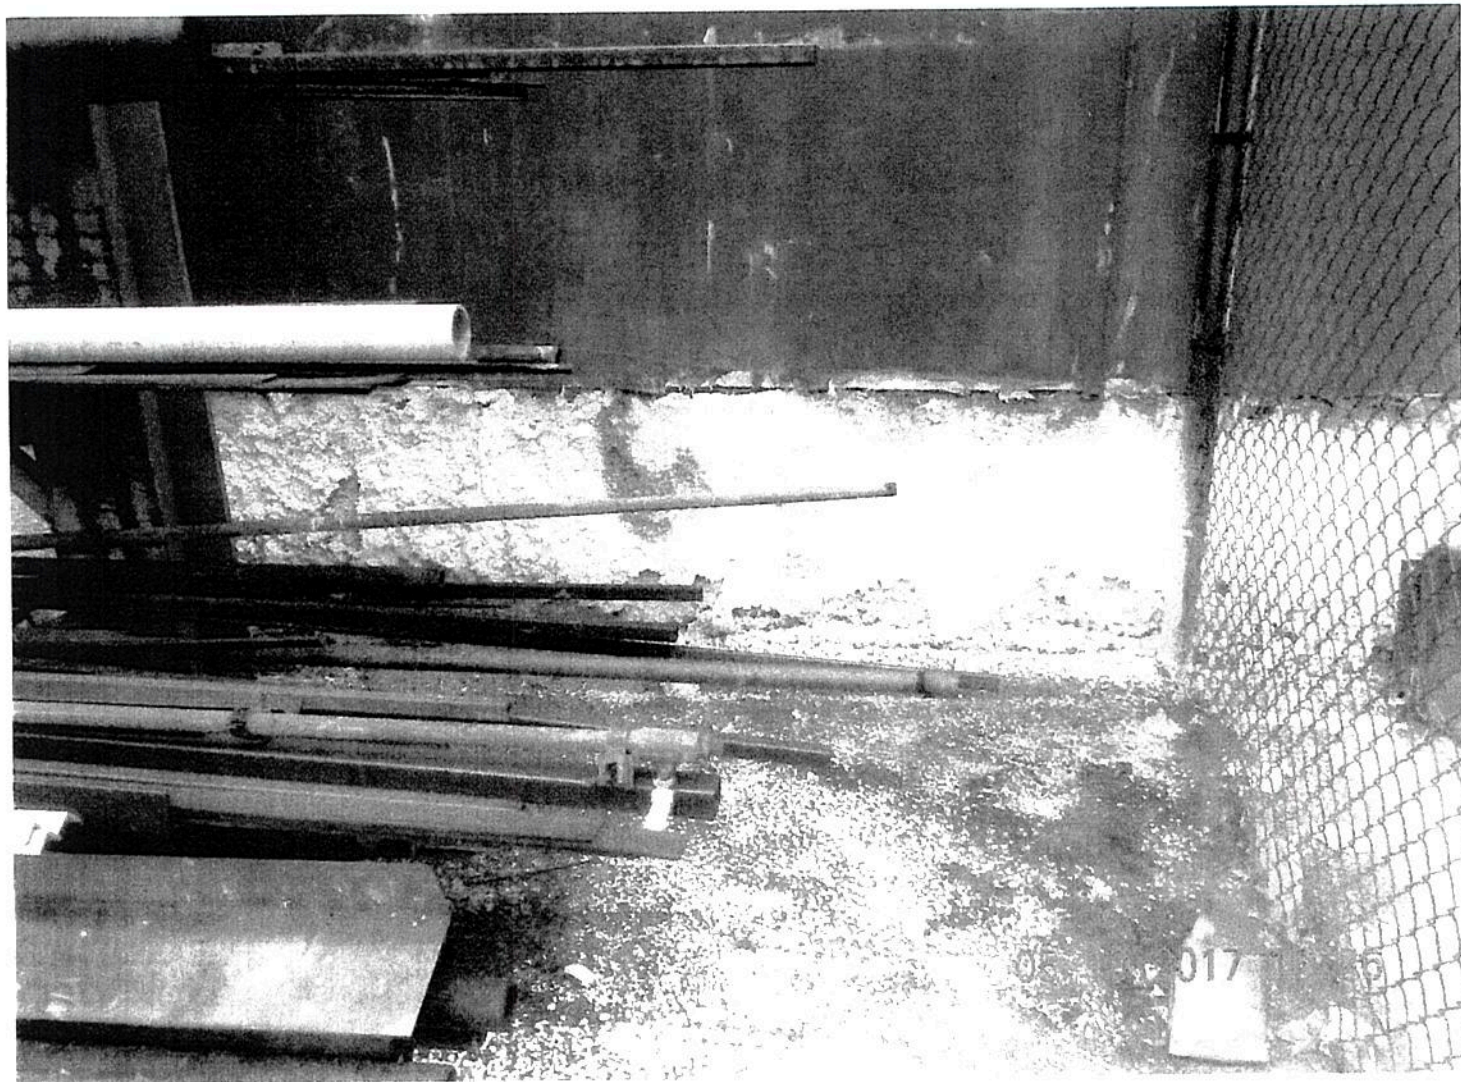
Pollutant Sources	Note location, quantitative description, design issue, O&M deficiencies (including the nature and extent), and pollutants off-site
5(A): Loading/Unloading Area	<i>No issues noted.</i>
5(B): Outdoor Storage Facilities	<i>No issues noted.</i>
5(C): Storm drains	<i>A trickle of water was observed in the storm drain # 1 (see photo No. DSCN1173).</i>
5(D): Housekeeping	<i>A potential source of pollutants was observed at an exterior wall outside the anodizing production line. A previous leak had been fixed in the area. However, EPA inspectors observed a sloughing of solid material off of a wall of the building at that location, depositing onto the ground and potentially contaminating stormwater runoff (see photos No. DSCN1171 and DSCN1172).</i>

8. *A potential source of pollutants was observed at an exterior wall outside the anodizing production line. A previous leak had been fixed, but inspectors observed a sloughing of solid material off of a wall of the building at that location, depositing onto the ground and potentially contaminating stormwater runoff*

Photos No. DSCN1171: *A potential source of pollutants was observed at an exterior wall outside the anodizing production line. A previous leak had been fixed in this area. However, EPA inspectors observed a sloughing of solid material off a wall of the building, depositing onto the ground, and potentially contaminating stormwater runoff.*

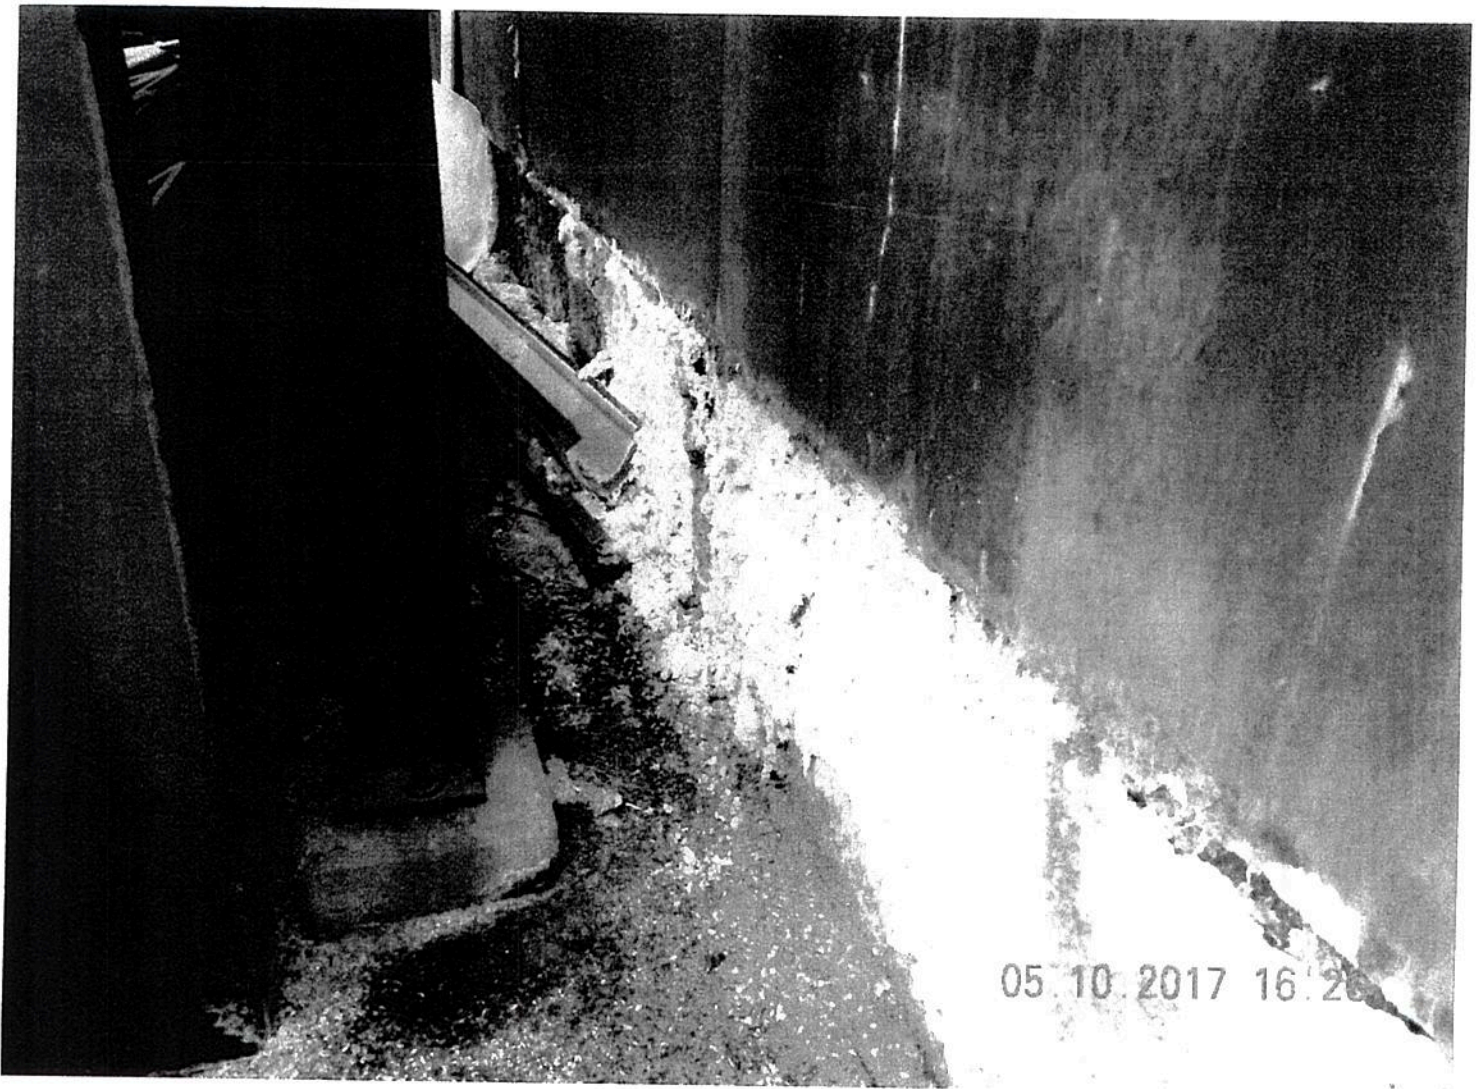
Photos No. DSCN1172: Side view of the potential source of pollutants observed at an exterior wall outside the anodizing production line.

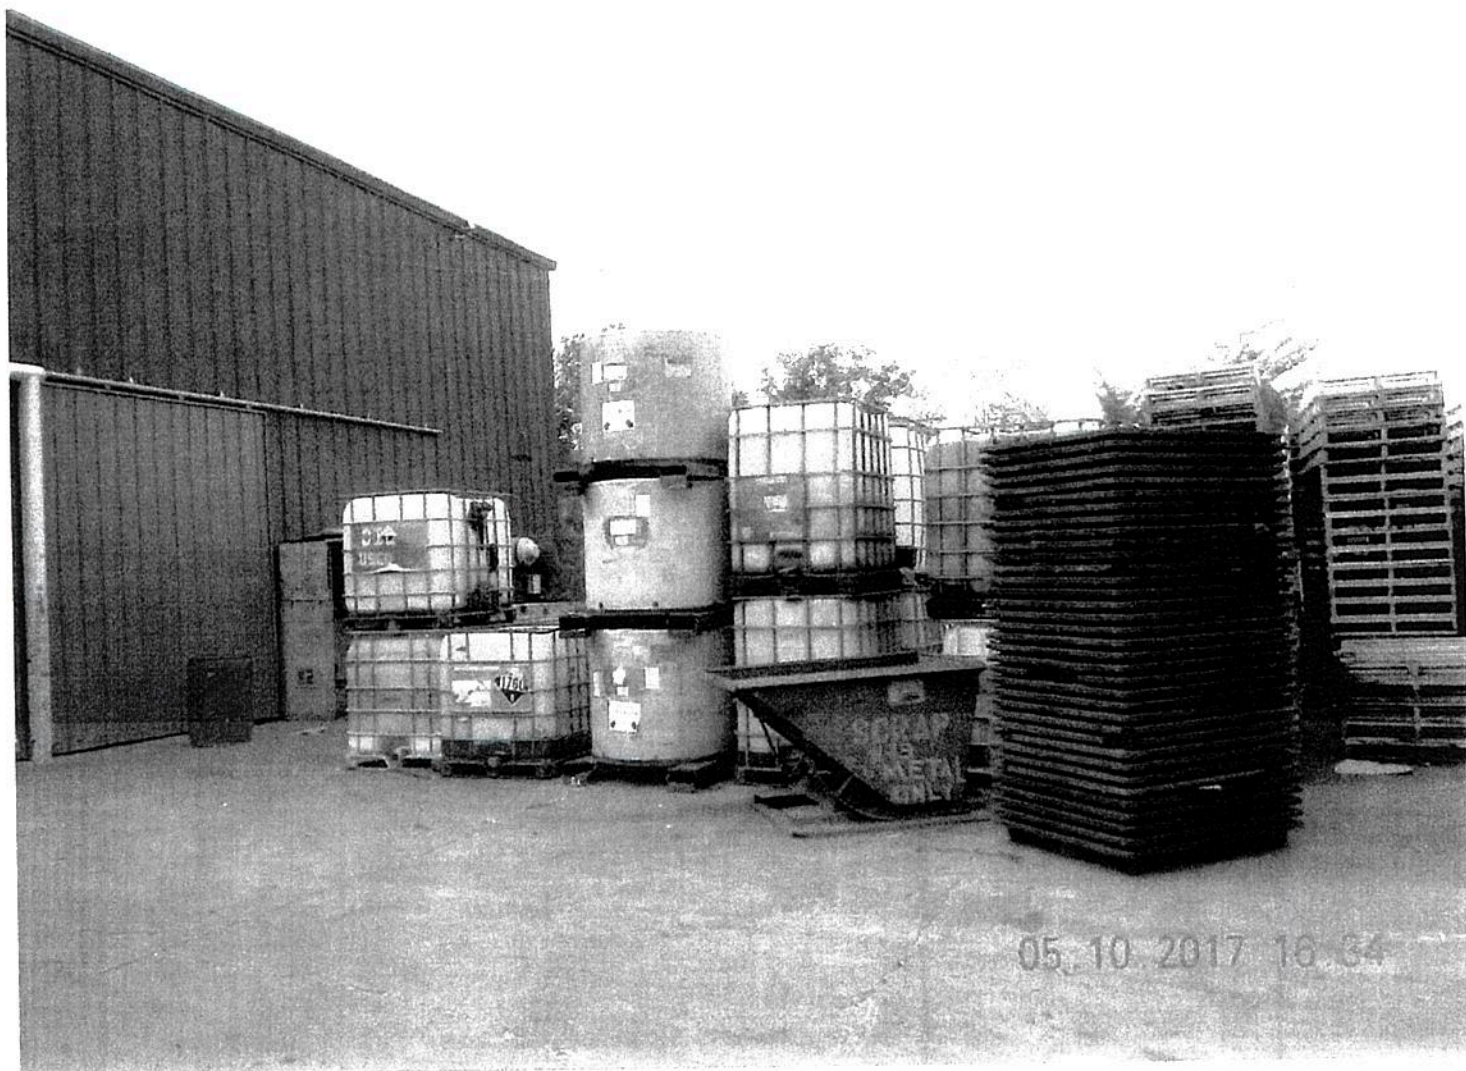
5(E): Liquid Storage Tanks	<i>Five 300 gallon totes were observed mostly full of used oil (see photo No. DSCN1177), and one additional red container of fresh hydraulic oil was also at the same location (see photo No. DSCN1178). No secondary containment was observed to control oil spillage. According to Spill Prevention Control, and Countermeasure (SPCC) Regulation under 40 CFR part 112, a facility is required to be covered by the SPCC rule if it has an aggregate aboveground oil storage capacity greater than 1,320 U.S. gallons. This facility has at least 1,500 gallon of oil storage capacity. Therefore, it must develop and implement an SPCC plan to address oil spill prevention, and spill cleanup procedures.</i>
5(F): Sediment & Erosion Controls (BMPs)	<i>No issues noted.</i>
5(G): Spills/Leaks Handling	<i>At the trash compactor near the southeast corner of the building, a white cloudy liquid was observed leaking onto the ground (see photo No. DSCN1165).</i>

9. *Five 300 gallon totes were observed mostly full of used oil, and one additional red container of fresh hydraulic oil was also at the same location. The facility may need to meet Spill Prevention Control, and Countermeasure (SPCC) Regulations.*

Photos No. DSCN1177: Five 300 gallon totes were observed mostly full of used oil. No secondary containment was observed to control oil spillage.

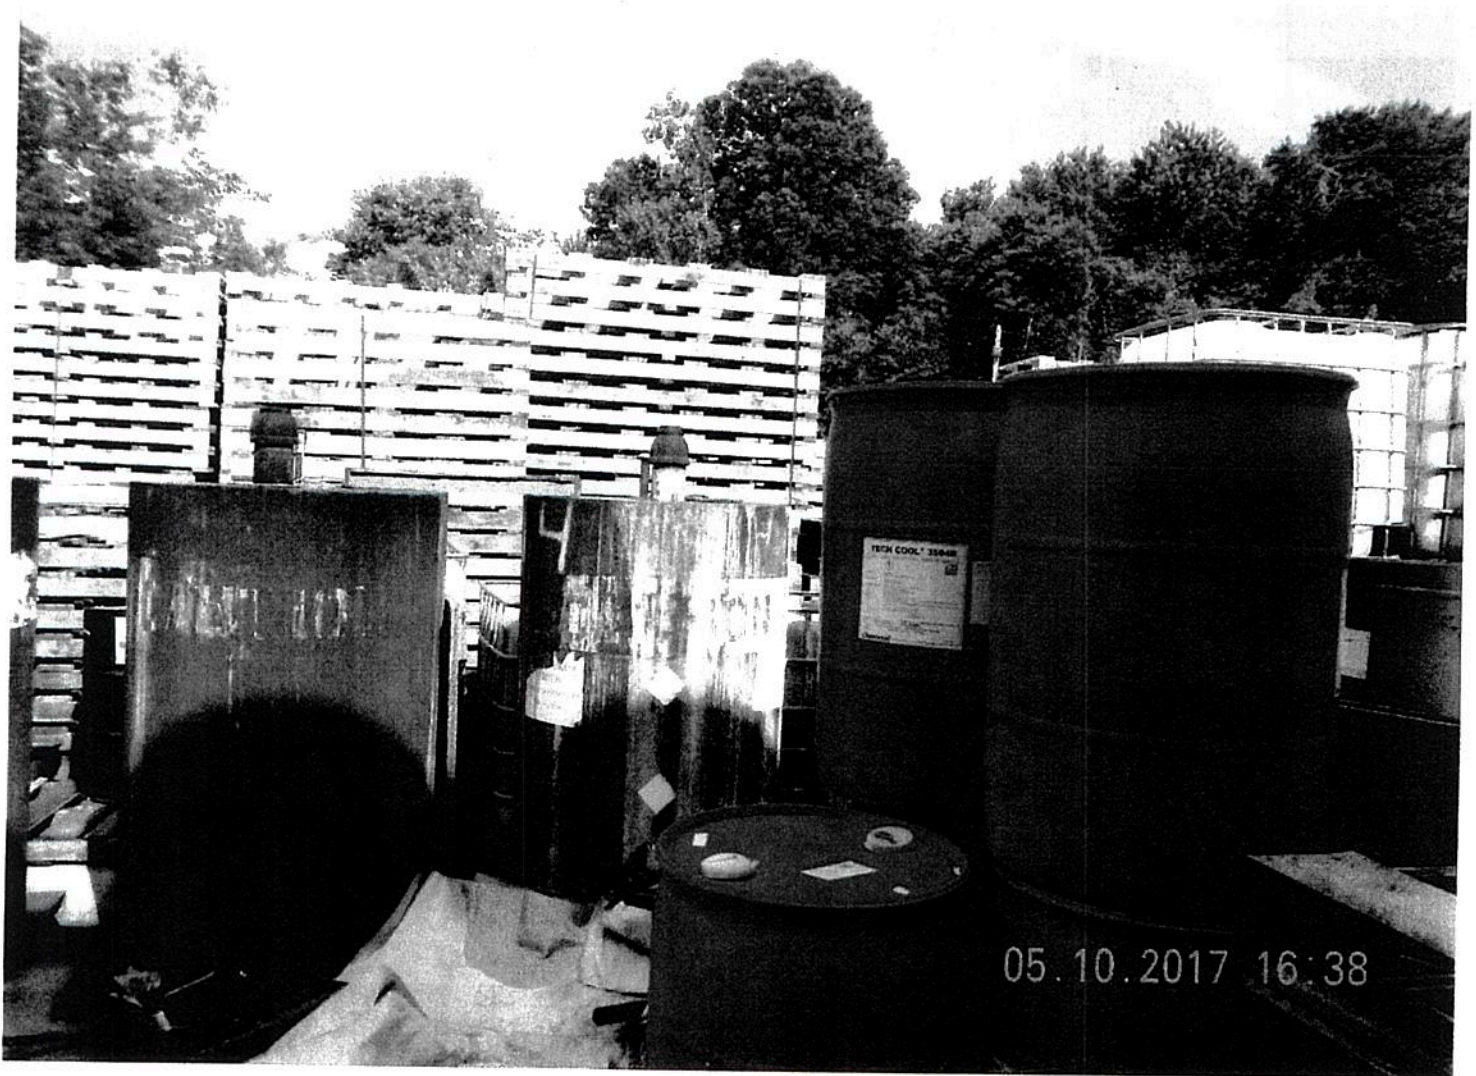
Photos No. DSCN1178: Drums and red container of fresh hydraulic oil with no secondary containment to control oil spillage.

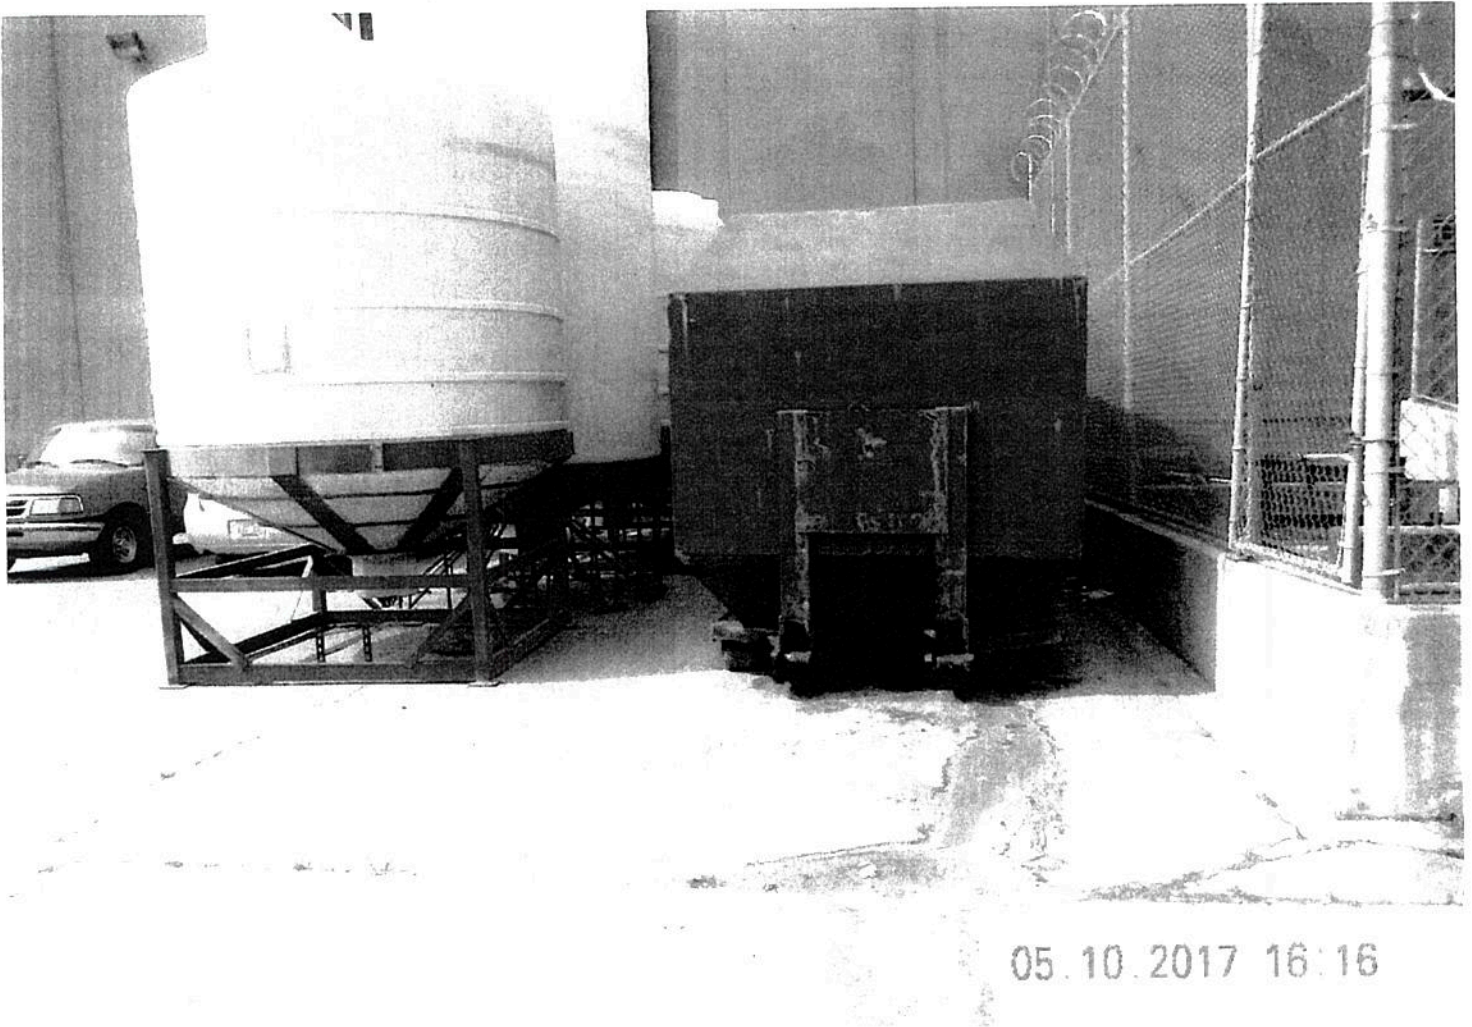
10. *At the trash compactor near the southeast corner of the building, a white cloudy liquid was observed leaking onto the ground.*

Photos No. DSCN1165: *At the trash compactor near the southeast corner of the building, a white cloudy liquid was observed leaking onto the ground.*

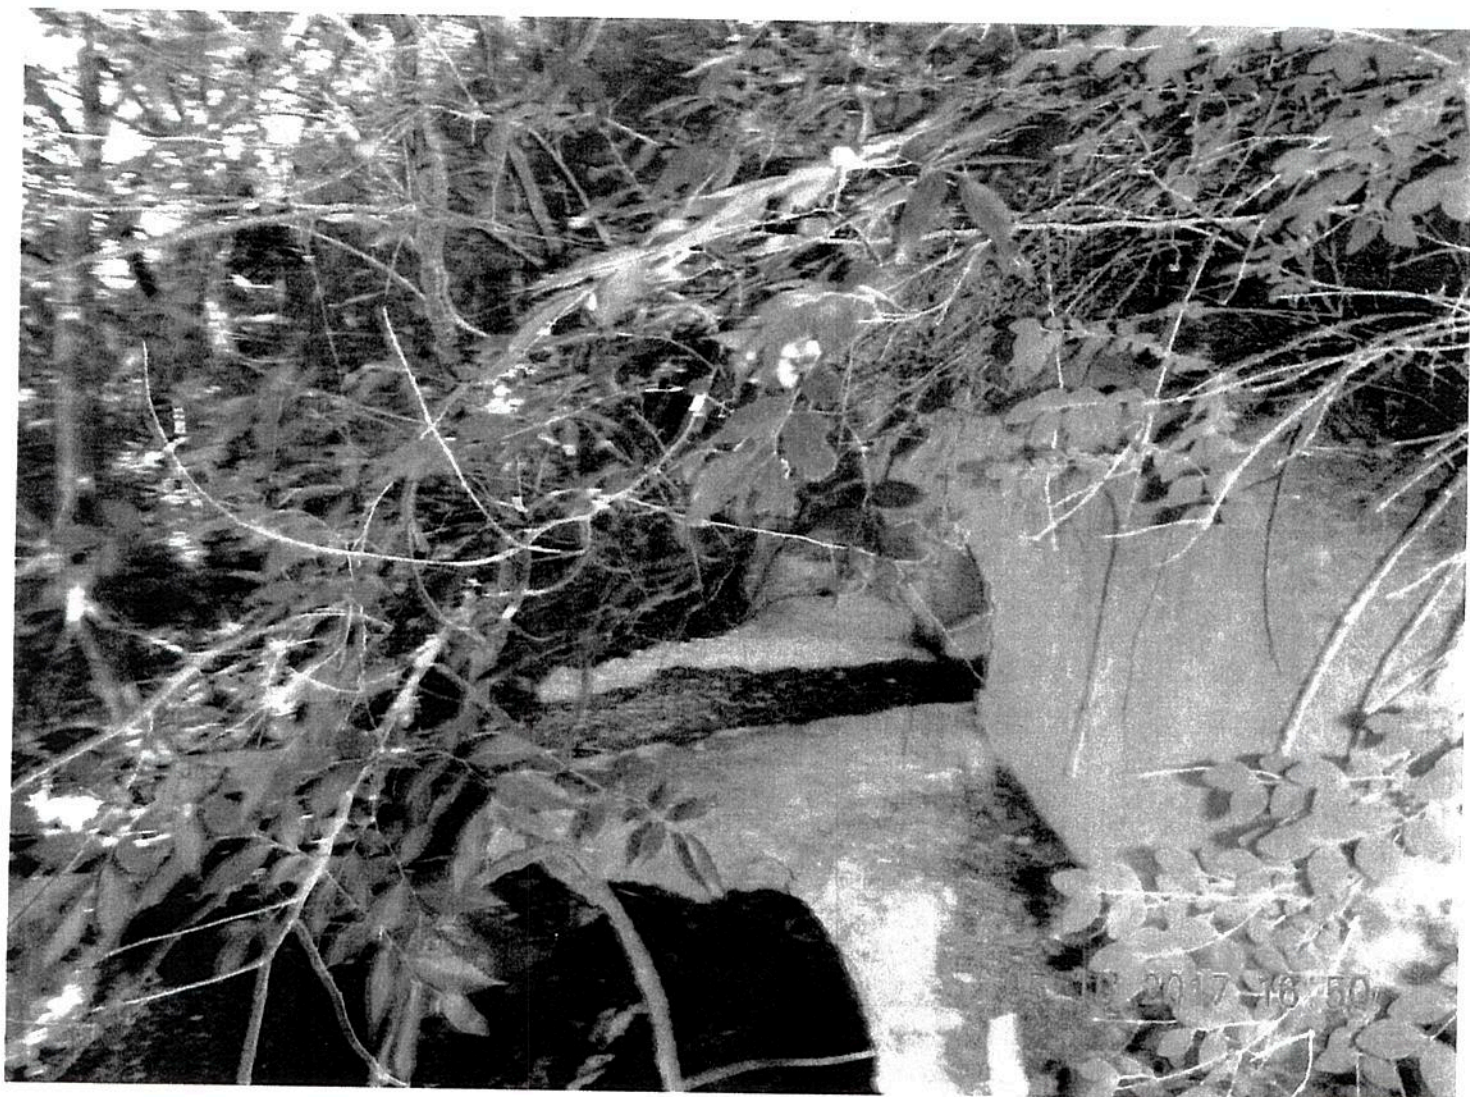
Outfall, Stormwater Discharge & Receiving Water	YES	NO	
6(A): Number & location of stormwater discharge(s)/outfall(s) consistent with the SWPPP	X		<i>Two outfalls as specified on the SWPPP.</i>
6(B): Evidence of off-site accumulation of pollutants observed in receiving water		X	<i>None observed.</i>
6(C): Other potential discharges off-site (through outfalls not included in the SWPPP)		X	<i>None observed.</i>
6(D): Non-stormwater discharge observed	X		<i>Outfall 001 (see photo No. DSCN1182) and 002 (see photo No. DSCN1179) both had a trickle of flow in dry weather conditions. Sources of these dry weather discharge are unknown.</i>

Photos No. DSCN1172: Outfall 002 had a trickle of flow in dry weather conditions. Sources of these dry weather discharge are unknown.

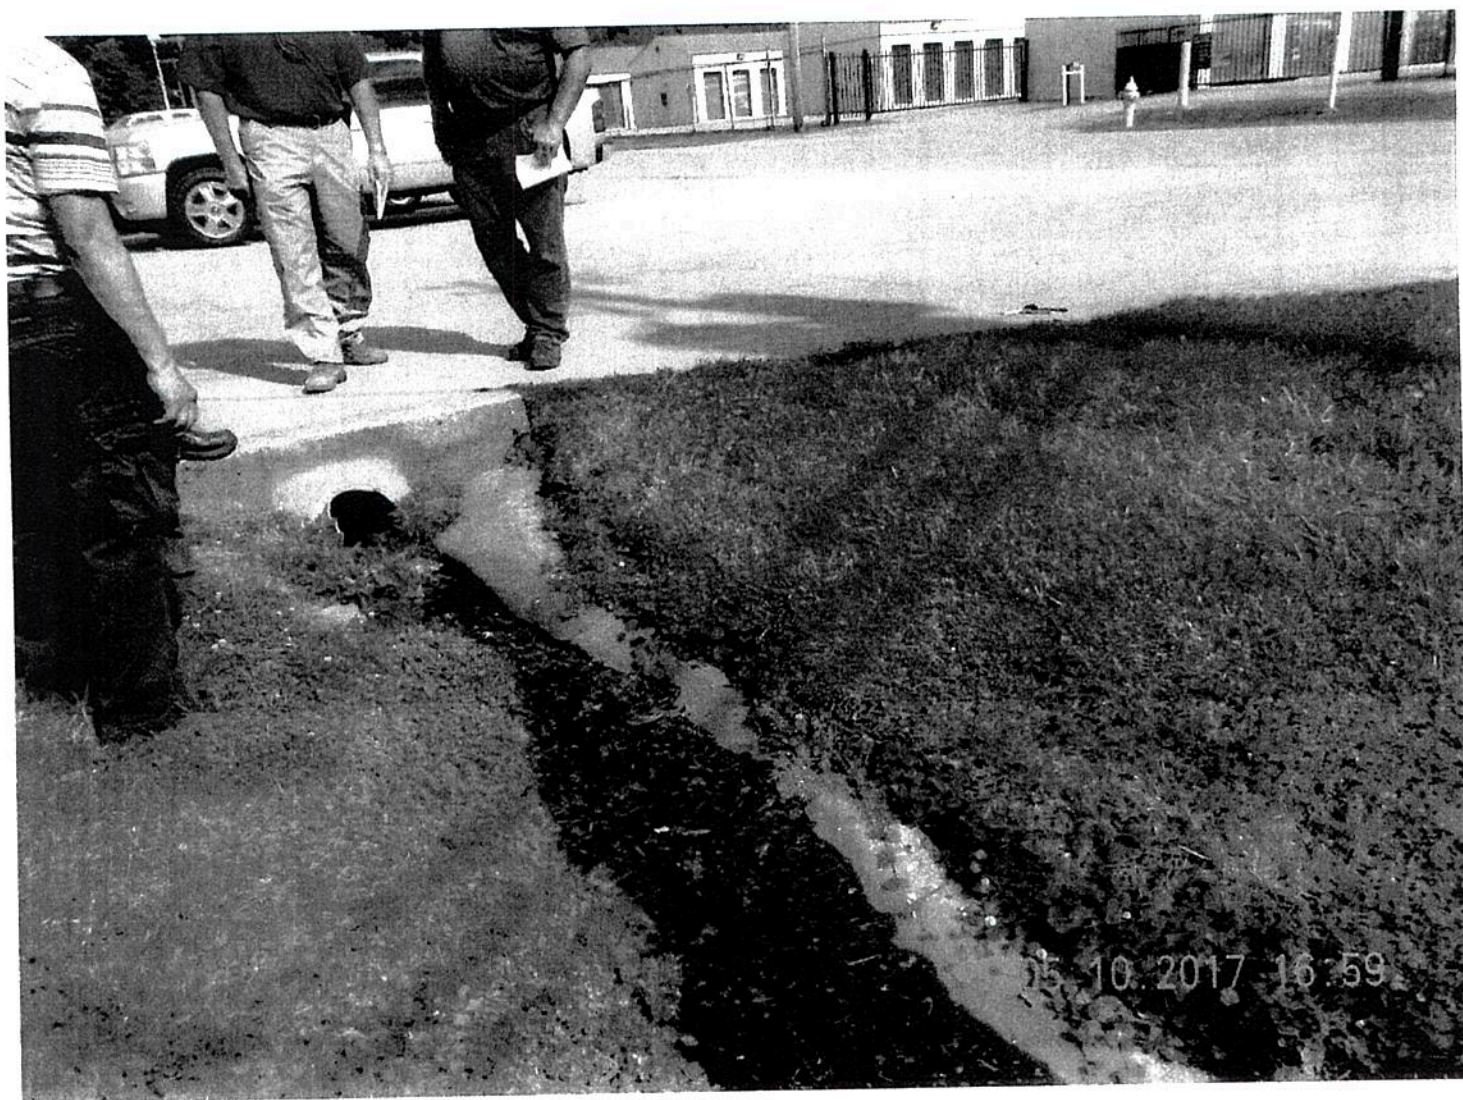
Photos No. DSCN1182: Outfall 001 had a trickle of flow in dry weather conditions. Sources of this dry weather discharges was unknown.
